Manhole Inspection Summary

Manhole # S19GG_003MH

Insp Date: **6/13/07 10:04 AM**

Location Address: **1618 PULASKI ST**

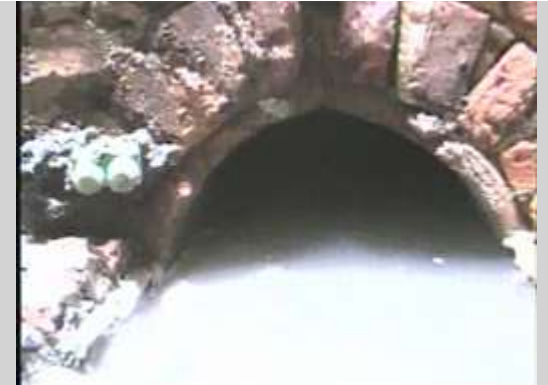
12 O'Clock Outflow

15 in. Circular Gravity Sewer
Pipe Out @ 12 O'Clock

Pipe Height: **14.4** (in.) Rod and Bar (Angled)
Pipe Material: **Clay** ☐ Pipe Lined
Invert Depth: **12.46** (ft.) Flow Characteristics: **Slow**
Deposits: ☒ None ☐ Mud ☐ Sludge ☐ Debris ☐ Grease
Silt Depth: (in.) Deposits Extent:
Infiltration: **None** Pipe Seal Cond: **Unknown**
